GPS Jamming and the Impact on Maritime Navigation

Alan Grant, Paul Williams, Nick Ward and Sally Basker
(*The General Lighthouse Authorities of the United Kingdom and Ireland*)

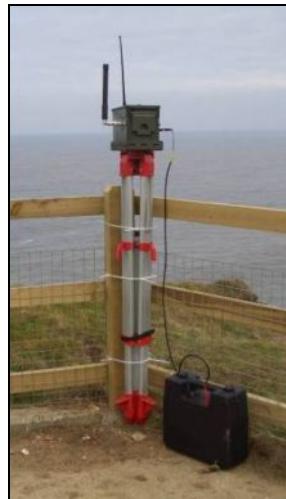
Figure 1: Main GPS jammer unit at Flamborough Head, shown with omni-directional antenna

2. *TRIAL METHODOLOGY*. The trial was conducted over several days during April 2008 at Flamborough Head on the East coast of the United Kingdom. DSTL provided a professional low-to-medium power jammer, which was controlled remotely by two VHF transceivers and transmitted a known pseudo-random noise code over the civilian L1 frequency providing a jamming signal over the whole 2MHz bandwidth of L1. Although the unit was capable of broadcasting on the P code, this was not activated. The total power of the signal over the 2MHz bandwidth was approximately 2dBW ($\sim 1.5\text{W}$) of power. This unit was used with either a "Qpar2003" directional antenna or an omni-directional antenna depending on the test being conducted (shown in Figure 1). The trial was conducted over three days, with two days devoted to dynamic trials and one day to static trials, each designed to test different elements of safe navigation.

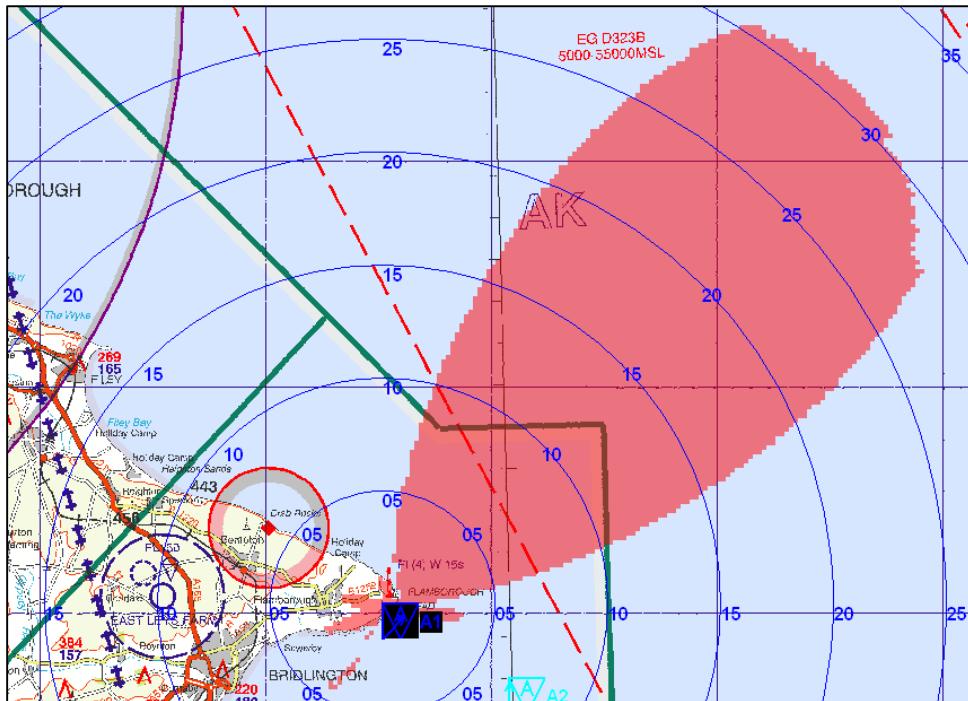
Figure 2 : Coverage area of the GPS jamming unit at 25m above ground level on maximum power of 1.58W ERP.
(Image courtesy of DSTL)

2.1 *Dynamic Trials*. For the dynamic trials, the Northern Lighthouse Board vessel *NLV Pole Star* steered a course back and forth between two waypoints on a path that dissected both the main lobe of the GPS jammer and the two side lobes, but with sufficient length beyond the jamming region to enable the various GPS enabled units to reacquire satellites (coverage of the jamming unit is shown in Figure 2).

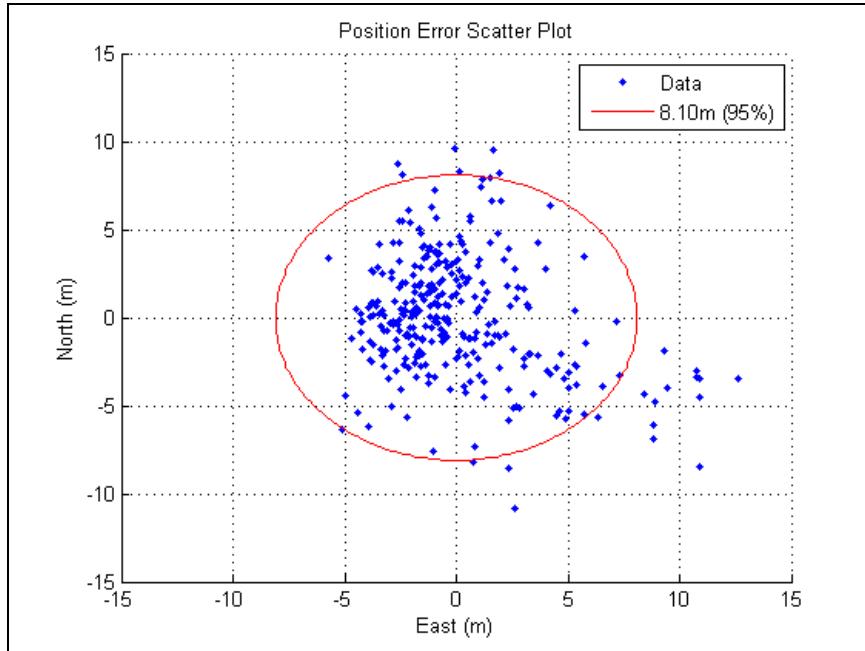
Figure 3: Scatter plot showing the performance of calibrated Lorain when compared to Differential GPS. Lorain was accurate to 8.1m (95%).

By using data collected during the control runs of the trial, it was possible to determine the positioning accuracy performance of Loran in the area of the trials. This was achieved by comparing calculated calibrated Loran positions against differential-GPS as provided by Eurofix. Figure 3 shows a scatter plot of the comparison of the Loran positions against the differentially corrected GPS positions. The red circle indicates a 95% position accuracy of 8.1m. It was only possible to assess the accuracy of calibrated Loran in this manner as the eLoran receiver will only revert to the other positioning modes, when GPS is not available and, since the receiver was moving, DGPS was required to provide the true position.

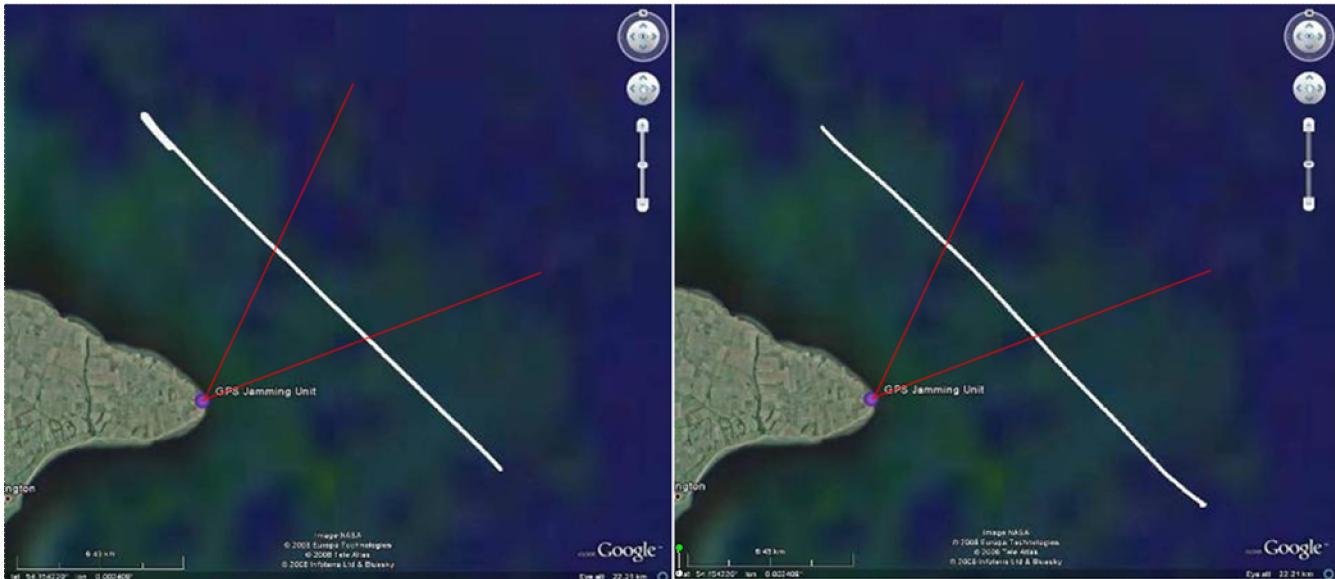
Figure 4 : Two plots of eLoran data displayed in Google Earth™. The left-hand plot is the reported positions during a control run when there was no GPS jamming. The right-hand plot shows the reported positions during a run with GPS jamming switched on. The red lines indicate the approximate boundaries of the main lobe of the GPS jamming signal. eLoran was not affected by GPS jamming.

Figure 4 shows eLoran derived position data as the vessel navigated through the jamming region under control conditions, when the jamming unit was not operating (left-hand plot), and when the GPS jamming unit was operating (right-hand plot). In both cases one can clearly see the route taken between the waypoints.

From the right-hand plot of Figure 4 it is possible to see that the eLoran receiver was able to provide a useable position output throughout the jamming trial. The only discrepancy between the two plots is a slight wave to the trace. This is due to the vessel being navigated using parallel indexing which is significantly less accurate than GPS and eLoran. Clearly the performance of eLoran is not affected by GPS jamming, as one would expect.

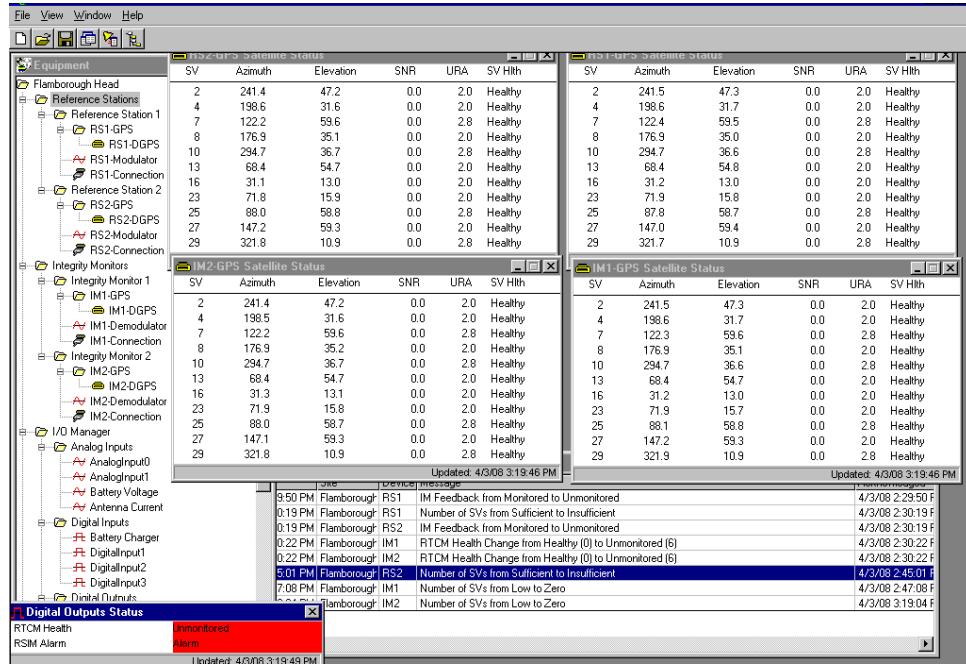
Figure 5: Screen shot of the Beacon Control Software (TM) at Flamborough Head showing that the Signal-to-Noise ratios (SNR) for all satellites on both reference stations and on both integrity monitors (4 windows to the top right of the image) are zero and that this has lead to the station issuing an alarm (red area at the bottom left of the screen).

The DGPS reference station at Flamborough Head was intentionally disrupted using the jamming unit on a reduced power. The power of the jamming unit was gradually increased until it affected the performance of the reference station. This was observed on the Trimble Beacon Control Software™ (BCS), which is used to control the reference station. Figure 5 shows a screenshot of the BCS software with a number of windows visible. The four windows on the top right of the image give details of the satellites being observed by the two reference stations in the top row (RS1 and RS2) and the two integrity monitors in the bottom row (IM1 and IM2). Within each of these windows the location and health details for each satellite being tracked are shown along with the signal-to-noise (SNR) ratios. Before the GPS jamming signal was enabled, typical SNR values of between 15 and 20 were observed for all satellites. When the power of the jamming signal was increased these SNR values fell and the number of satellites used by the reference station and integrity monitor units reduced until there were no usable satellites. The reference station raised an alarm when the number of satellites fell below the required minimum, showing that GPS jamming does affect the performance of Differential GPS reference stations as expected.

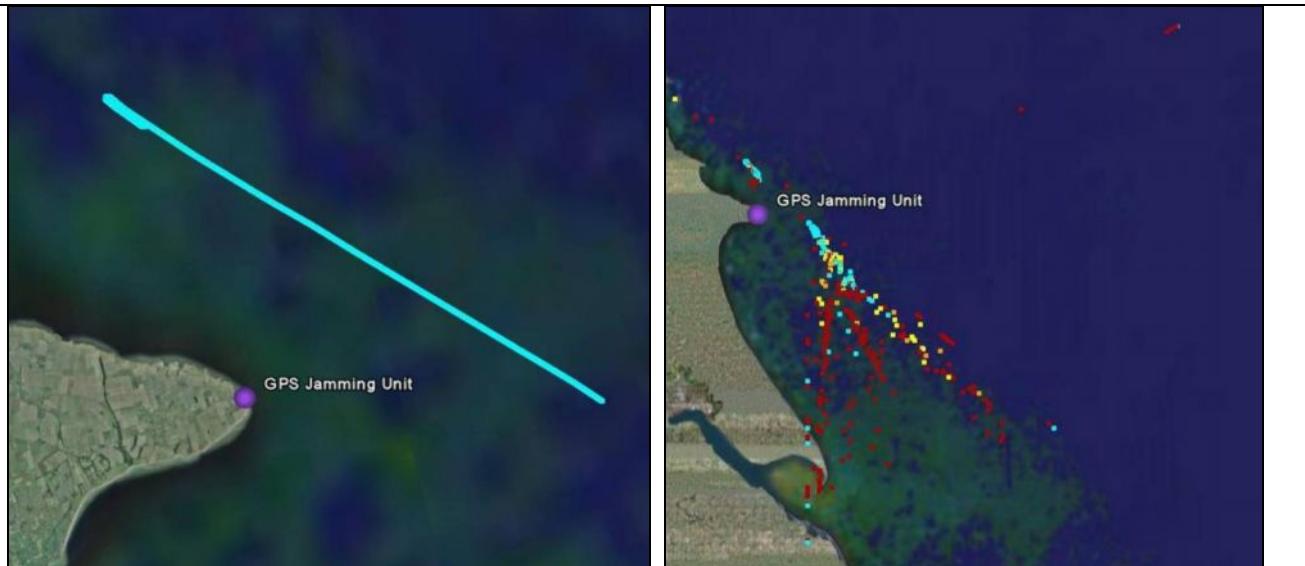
Figure 6 : Google Earth™ plot of recorded positions identified as valid, with no GPS jamming unit active.

The colours are used to represent the reported vessel speed with blue <15knts, yellow< 50knts, orange <100knts and red >100knts.

Figure 7 : Google Earth™ plot of recorded positions identified as valid, with GPS jamming unit active.

Over the course of the dynamic trials the receivers were monitored and all of them lost GPS lock. The two differential receivers maintained lock on the medium frequency broadcast from the nearby Flamborough Head DGPS reference station; however as the reference station was also affected by the jamming signal, there were no corrections to apply and their position solution was derived from stand-alone GPS. When processing the recorded data from the three receivers, the NMEA GPRMC (recommended minimum content) sentence was used as this provides the reported position, speed and time. This sentence also provides an indication of the validity of the data, setting or clearing a single bit flag. The decision to set or clear the data valid flag is one that is made by the receiver. When processing the recorded data from the various receivers only data declared valid was used, which resulted in the two typical marine grade receivers providing erroneous positions as they entered and exited the jamming region. The magnitude of the position error varied, with some small errors, but with others several tens of kilometres away from the true location. Figures 6 and 7 provide the reported positions from one receiver, plotted on Google Earth™. The left-hand plot is from the control run where the jamming unit was disabled; the right-hand plot is from a run where the jamming unit was enabled and erroneous data was observed. The colour of each reported position is an indication of the reported vessel speed at that moment, with blue positions indicating a speed of less than 15 knots; yellow positions indicating a speed of between 16 and 50 knots; orange positions indicating a speed of between 51 and 100 knots and red positions indicating a reported speed of greater than 100 knots.

Figure 7 shows that the number of erroneous positions was significant with the majority of positions coloured red, indicating the reported speed was greater than 100 knots (the greatest reported speed was over 5000 knots). Clearly, if this data was being used as input to a navigation system, whether it was an autopilot or simply an Electronic Chart the implications are serious. The results shown in Figure 7 were typical from the two marine grade receivers, although it was noted that the effect of jamming was more severe when sailing North with the vessel superstructure between the jamming unit and the GNSS receivers' antennas. Therefore, it may be presumed that the jamming signal

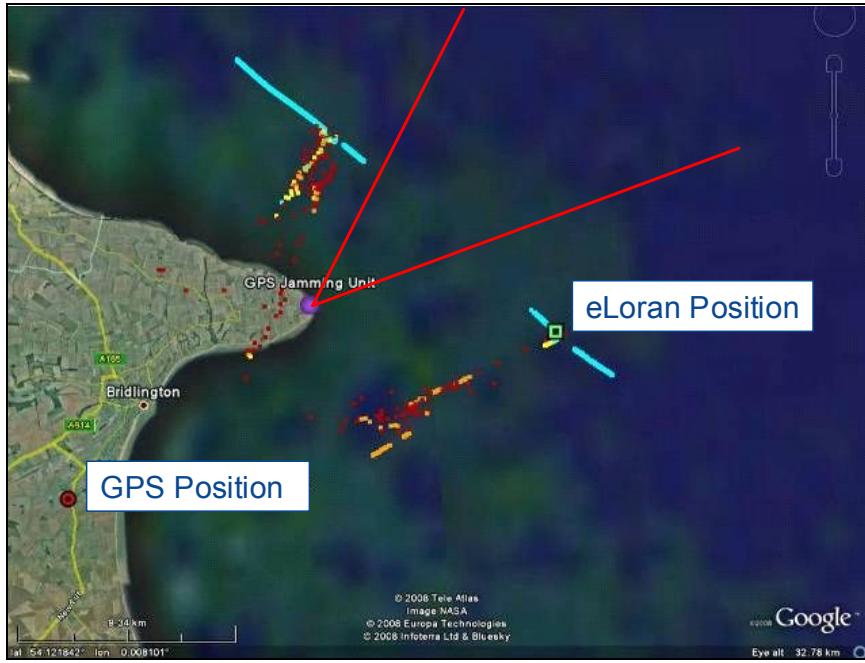
Figure 8 : Google Earth™ Plot of valid GPRMC data from one of the typical marine grade receivers with the comparison of an erroneous GPS position (red circle) against the eLoran position (green square) for the same time. The GPS position is reported as being inland 22Km West from the true eLoran position. (Red lines indicate main lobe of the jamming unit and position colours indicate reported speed: blue <15knts, yellow < 50knts, orange <100knts and red >100knts)

As noted in Section 4.1, the reported position from eLoran was not affected during GPS jamming and the receiver was able to function as normal, as one would expect. In order to calculate the magnitude of error, an erroneous position from one of the typical marine grade receivers is compared to that from the eLoran receiver for the same moment in time, in Figure 8.

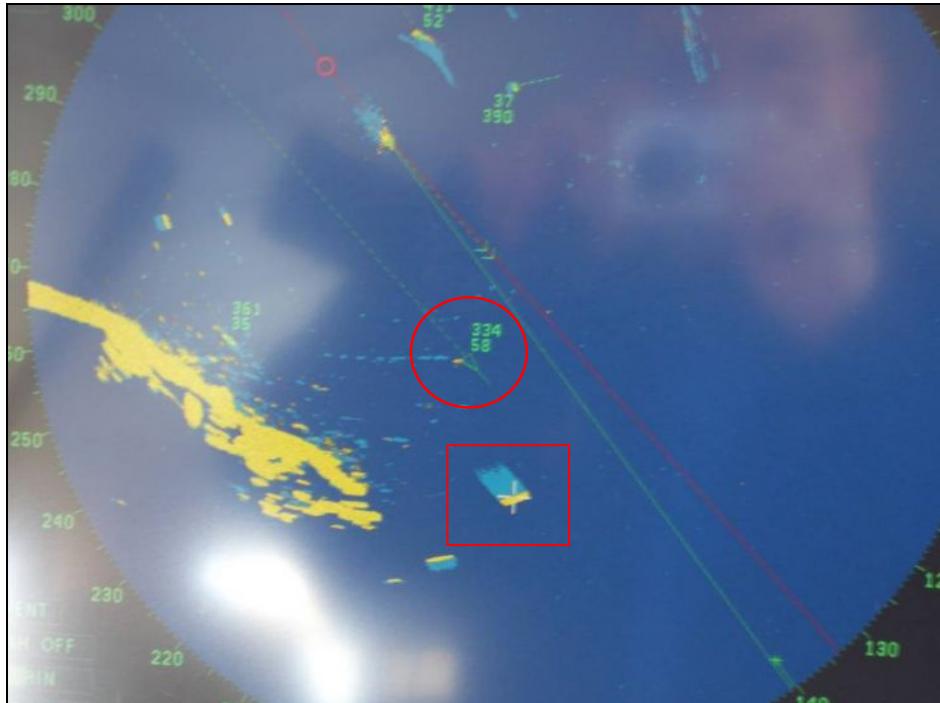
Figure 9 : Photo of NLV Pole Star's radar with AIS overlay: Note the yellow crosshair (red square) indicates the radar return of vessel “33458” whose AIS position is reported to be some distance to the North (red circle).

By observing the radar display, one could see one of the more significant effects of GPS jamming, one with hazardous consequences. Figure 9 shows a photograph of *Pole Star*'s radar display. On the radar there is a crosshair (marked in the red square), which highlights the radar return for a nearby vessel. That vessel's reported position via AIS is considerably further to the north (vessel number 33458, highlighted in the red circle), clearly showing the effect of jamming on the GPS receiver onboard this vessel, which is resulting in an erroneous AIS reported position.

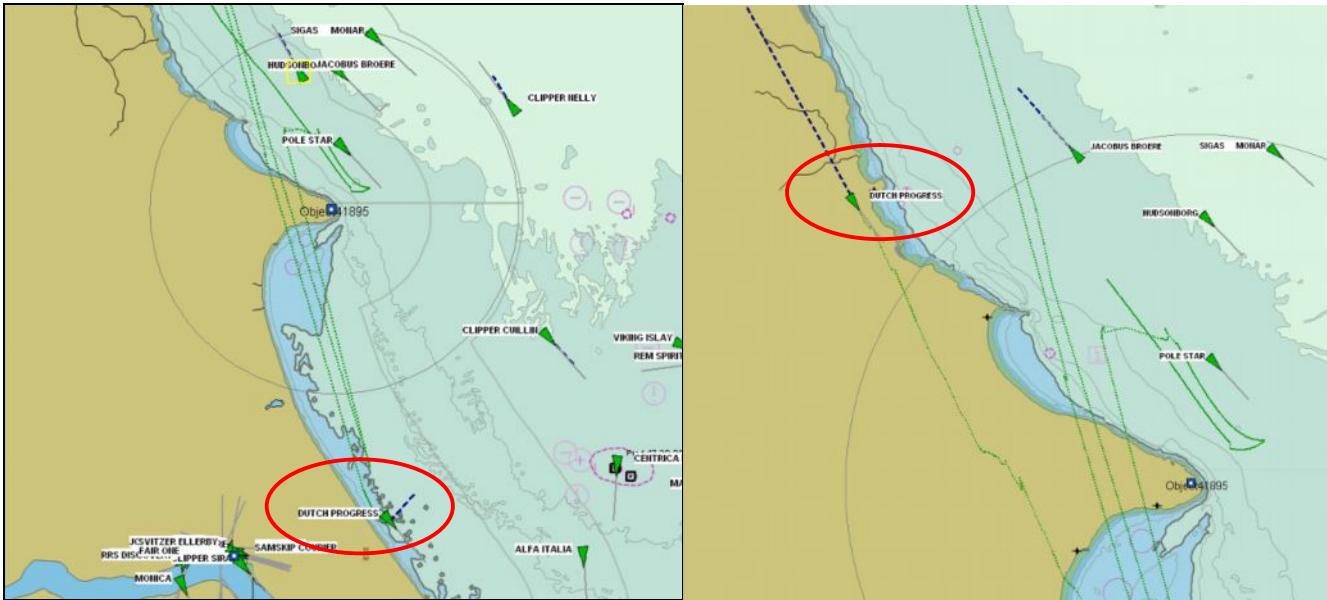
Figure 10: AIS traces as observed from the MCA station at Flamborough. Note the recorded trace of *NLV Pole Star* as she passed through the GPS service denial region. The trace not only extends further north and south than the true passage, it also shows the vessel crossing the land. The location of “Dutch Progress” is also marked as her position changes due to erroneous GPS input to her AIS.

The effect of GPS jamming can also be observed in Figure 10, which was provided by the Maritime and Coastguard Agency (MCA) and was recorded from their AIS base station in Flamborough. The figure shows a series of snapshots of the maritime traffic off the East coast of Flamborough, with the left-hand image preceding the right-hand image by a few seconds.

In the centre of both images is the reported position of the trial vessel *NLV Pole Star*, which was being tracked and one can see the green trace over the peninsular as a result of several runs between the two defined waypoints. The image is taken while the GPS receiver that provides *Pole Star*'s AIS position is in the “period of indecision” and is wandering around. These images give an indication of the effect of GPS jamming on other vessels in the vicinity. On these AIS plots, vessels are identified by green triangles, the orientation of which provides an indication of the vessels' respective headings (the direction in which the vessels are pointing). The course-over-ground of each vessel is indicated by the blue dashed line (the direction in which the vessels are moving), with the length of the line indicating the vessel's speed. Most vessels are seemingly not affected and their reported position data looks normal - the vessel's heading and course-over-ground agree with each other.

However, if one compares the vessel highlighted in the two images, the “Dutch Progress”, she is clearly being affected by GPS jamming. In the left-hand image, the vessel is South of *Pole Star* and reporting that she is travelling in a South Easterly direction, although the reported course over ground is North East. However if one then compares the reported position in the right-hand image, taken a few seconds later, her location has moved North by some way and one sees that she is reported to be inland while showing a heading of South East. Her course-over-ground is in the opposite direction and with a significant speed. This is a result of the vessel's GPS reporting erroneous positions and as such the vessel's reported position jumps around randomly.
